PIPER FLYER

SARATOGA SCHOOL: What you need to know about the PA-32 and its systems

Buying and maintaining a Saratoga doesn't have to be confusing, provided you have all the facts.

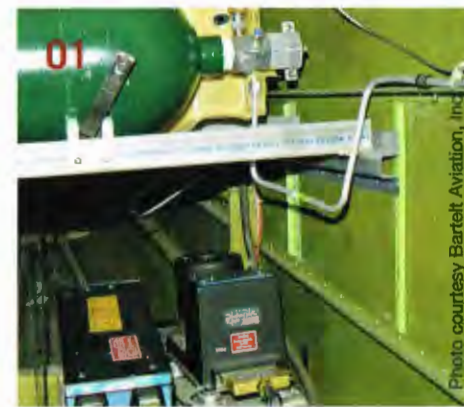
Cracked Oxygen Support Brackets

ment. "We find these brackets cracked on many of the 1980 to 1987 Turbo Saratoga SPs," Bartelt informed me. If it's not fixed, you risk cracking of the fuselage side skins.

Bartelt Aviation is finding cracks in oxygen support brackets on 1980 to 1987 Turbo Saratoga SPs. To fix the issue, old brackets need to be drilled out and new ones riveted in place.

01 The left-hand inside support bracket.

It takes about eight hours of labor to drill out the cracked brackets and rivet new units in place. Each vertical bracket costs about \$70, and there are four brackets. Additional labor is needed to remove and replace the rear bulkhead and oxygen bottle to gain access.

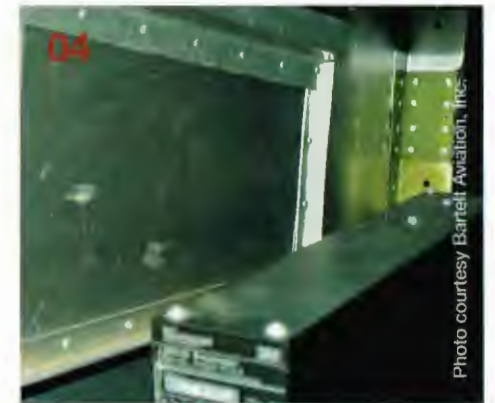
04 A photo illustrating the view from the aft side.

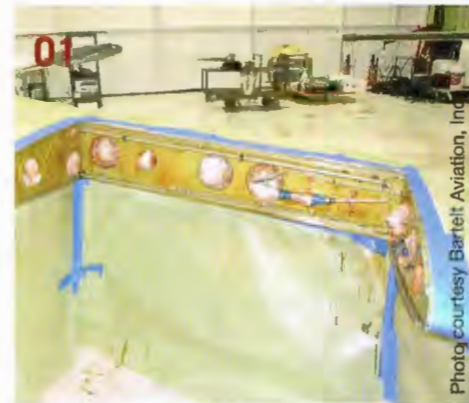
Service Bulletin 1006 – Corrosion Inspection of Main Spar

Reports of significant corrosion on the spar cap behind the fuel tanks in PA-28 and PA-32 series aircraft prompted the issuance of Service Bulletin 1006 in 1997.

01 This bulletin requires around 25 hours of labor to complete. If corrosion is missed, a loss of structural integrity in the spar can result.

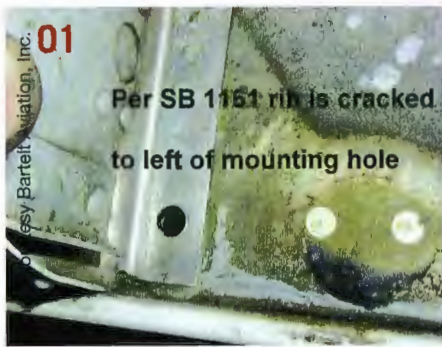
01 Per SB 1161 rib is cracked to left of mounting hole

According to Service Bulletin 1161, "The rib assembly on the aft side of the main wing spar at wing station 49.25 may develop a crack, located vertically along the bend radius of the flange..."

01 This photo clearly illustrates the rib crack on the right hand side. 02 If the crack is small enough, it can be repaired with a bracket. 03 A crack detected in the left hand side of this rib assembly. 04 This left hand kit requires 12 to 16 hours to install.

Bartelt says he has seen evidence of these ribs cracking, and if it's not addressed, the crack could exceed the effectiveness of the repair kit. The kit costs less than \$350, but between 12 and 16 hours of labor per side are needed in order to complete the installation.

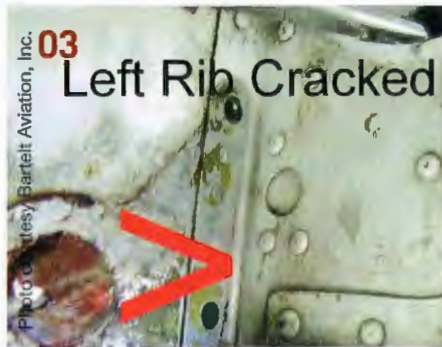
03 Left Rib Cracked

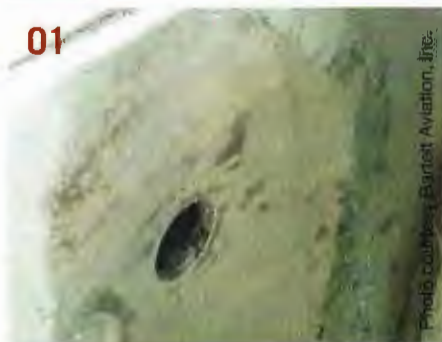
Bartelt explains further. "There are two rivnuts—female receptacles for bolts—these go in to the rib for the aileron attach arm mounting. The majority of the Saratoga aileron ribs we inspect are cracked," he said. To change the rib, the cost is about \$900 per side, plus two hours per aileron.

A mandatory inspection for aileron rib cracks is detailed in Service Bulletin 1216B issued in 2012. 01 A closeup of an aileron rib crack. 02 The crack is more easily seen when magnified. 03 A shot of the aircraft with a cracked aileron rib. 04 In this photo the aileron rib has been replaced.
