PIPER FLYER

SARATOGA SCHOOL: What you need to know about the PA-32 and its systems

Buying and maintaining a Saratoga doesn't have to be confusing, provided you have all the facts.

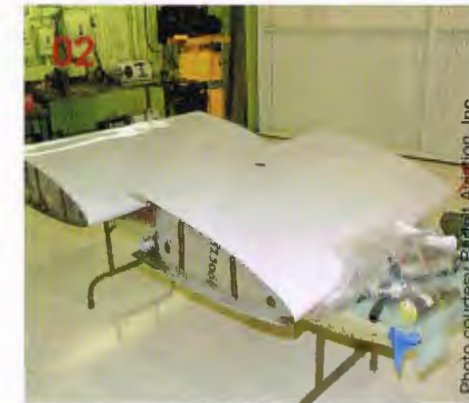
49.25 may develop a crack, located vertically along the bend radius of the flange common to the main wing spar and the side brace attach fitting."

Bartelt says he has seen evidence of these ribs cracking, and if it's not addressed, the crack could exceed the effectiveness of the repair kit. The kit costs less than \$350, but between 12 and 16 hours of labor per side are needed in order to complete the installation.

01 Per SB 1161 rib is cracked to left of mounting hole

01 This photo clearly illustrates the rib crack on the right hand side. 02 If the crack is small enough, it can be repaired with a bracket. 03 A crack detected in the left hand side of this rib assembly. 04 This left hand kit requires 12 to 16 hours to install.
